# SPECIAL AIRWORTHINESS INFORMATION BULLETIN

No. NE-03-56  
September 19, 2003

This Special Airworthiness Information Bulletin (SAIB) provides information on the inspection requirements for the **Schweizer Model 269C-1** Aft Mast Support Strut, P/N 269A2172-5.

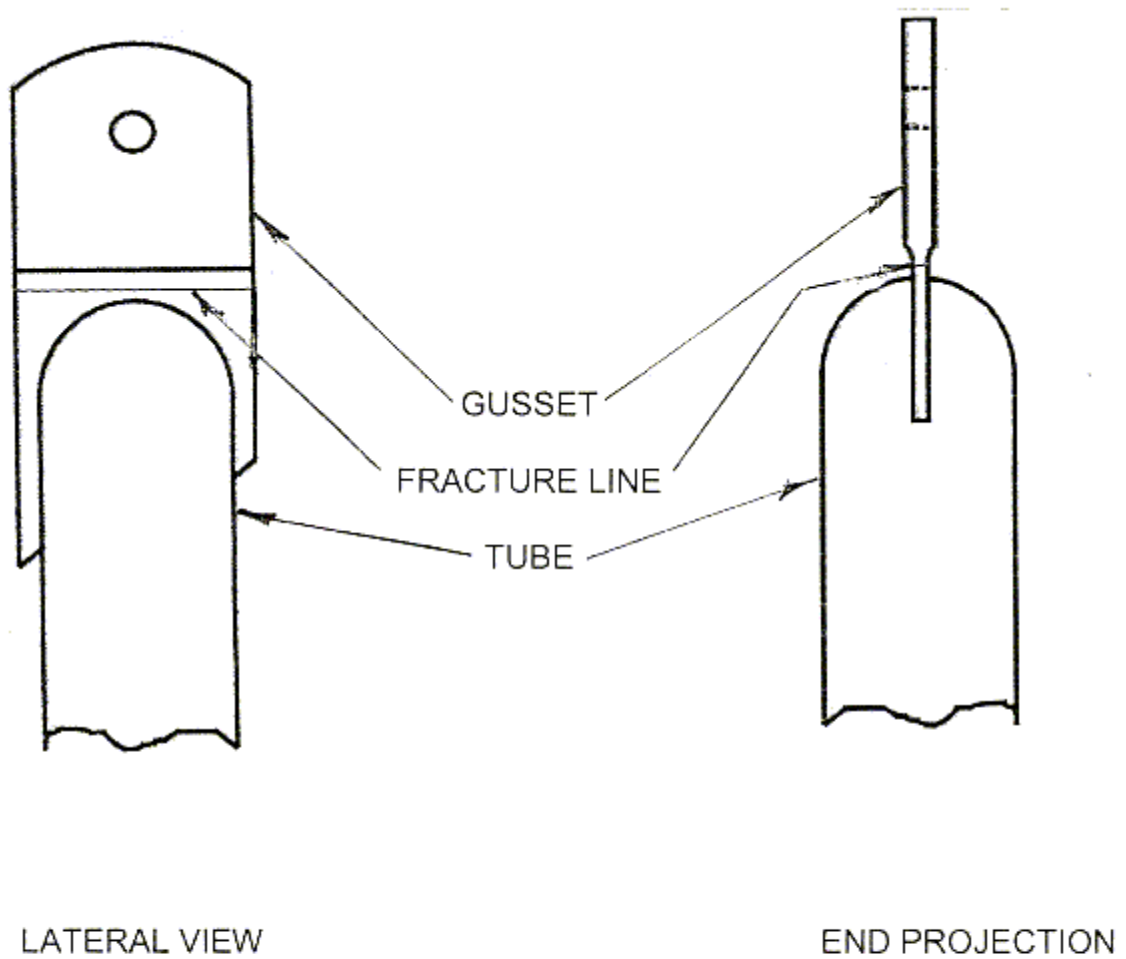
Since August 1997, there have been three cases of Schweizer Model 269C-1 Aft Mast Support Strut, P/N 269A2172-5 (Support Strut) failures at very low time in service (TIS): 38.3, 142 and 36.6 hours. The Support Strut is not a life limited part. In July 2002, a similar strut failure occurred at 1609 hours TIS on an aircraft that had a previous in-flight engine failure and a tailboom replacement. A spare sale on January 22, 2003 has also been traced to a replacement for a cracked gusset (TIS not known). Although the failures occurred at the same location in a gusset that is used on all Schweizer models, the failures have been limited to the 269C-1 models. Failure of the Support Strut may lead to loss of control of the helicopter, and subsequently cause property damage, injury or death.

There are two strut configurations with the same part number (269A2172-5): the original configuration uses an end gusset that has two thicknesses where the thinner portion is welded to the strut tube; the modified configuration, which was initiated in December 2001, uses an end gusset with a single thickness that is equal to the thickness of the thicker portion of the original gusset. The critical section is on the forward gusset (Drawing No. 269A2204) of the original configuration at the thinner section between the toe of the fillet weld and the change-in-thickness fillet radius (Fig. 1). Both gusset configurations are approved for flight. The new version was introduced as a product improvement, and was phased in during depletion of the old configuration.

The exact cause of the failures has not been determined, but metallurgical examination of the failed parts has ruled out defective welds.

Figure 1. Schematic drawing of the forward end of Schweizer Model 269C-1 Aft Mast Support Strut showing the original two-step gusset and fracture line.

The 100-hour HMI inspection procedures for the strut gussets, as currently required, should be carried out with great care.

Whenever the Aft Mast Support Strut is installed on the vehicle, extreme care should be exercised to preclude bending of the gusset at the critical section. Such bending could occur when the forward connection (mast) is made first, followed by the aft connection (boom).
